# Combustion Inspection Elimination Kit

**High-tech process to eliminate the requirement for combustion outages between HGP and Major overhauls.**

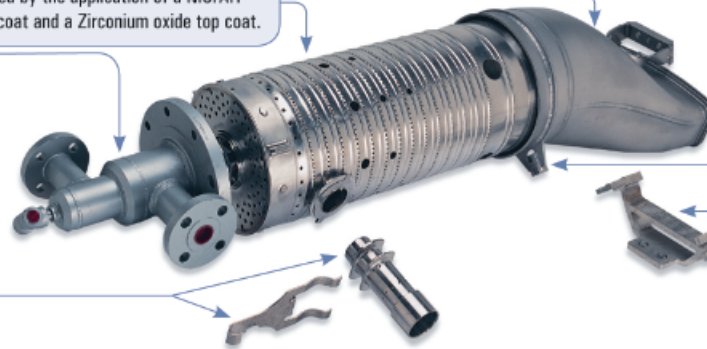
### H-Block Anangement

Wear-resistant material inserts are welded to the existing H-Blocks. These two locations mate with the forward transition piece support bracket (Bull horn support).
